# **Expedient Shelter Construction and Occupancy Experiments**

Cresson H. Kearny

**OAK RIDGE NATIONAL LABORATORY**

MARCH 1976

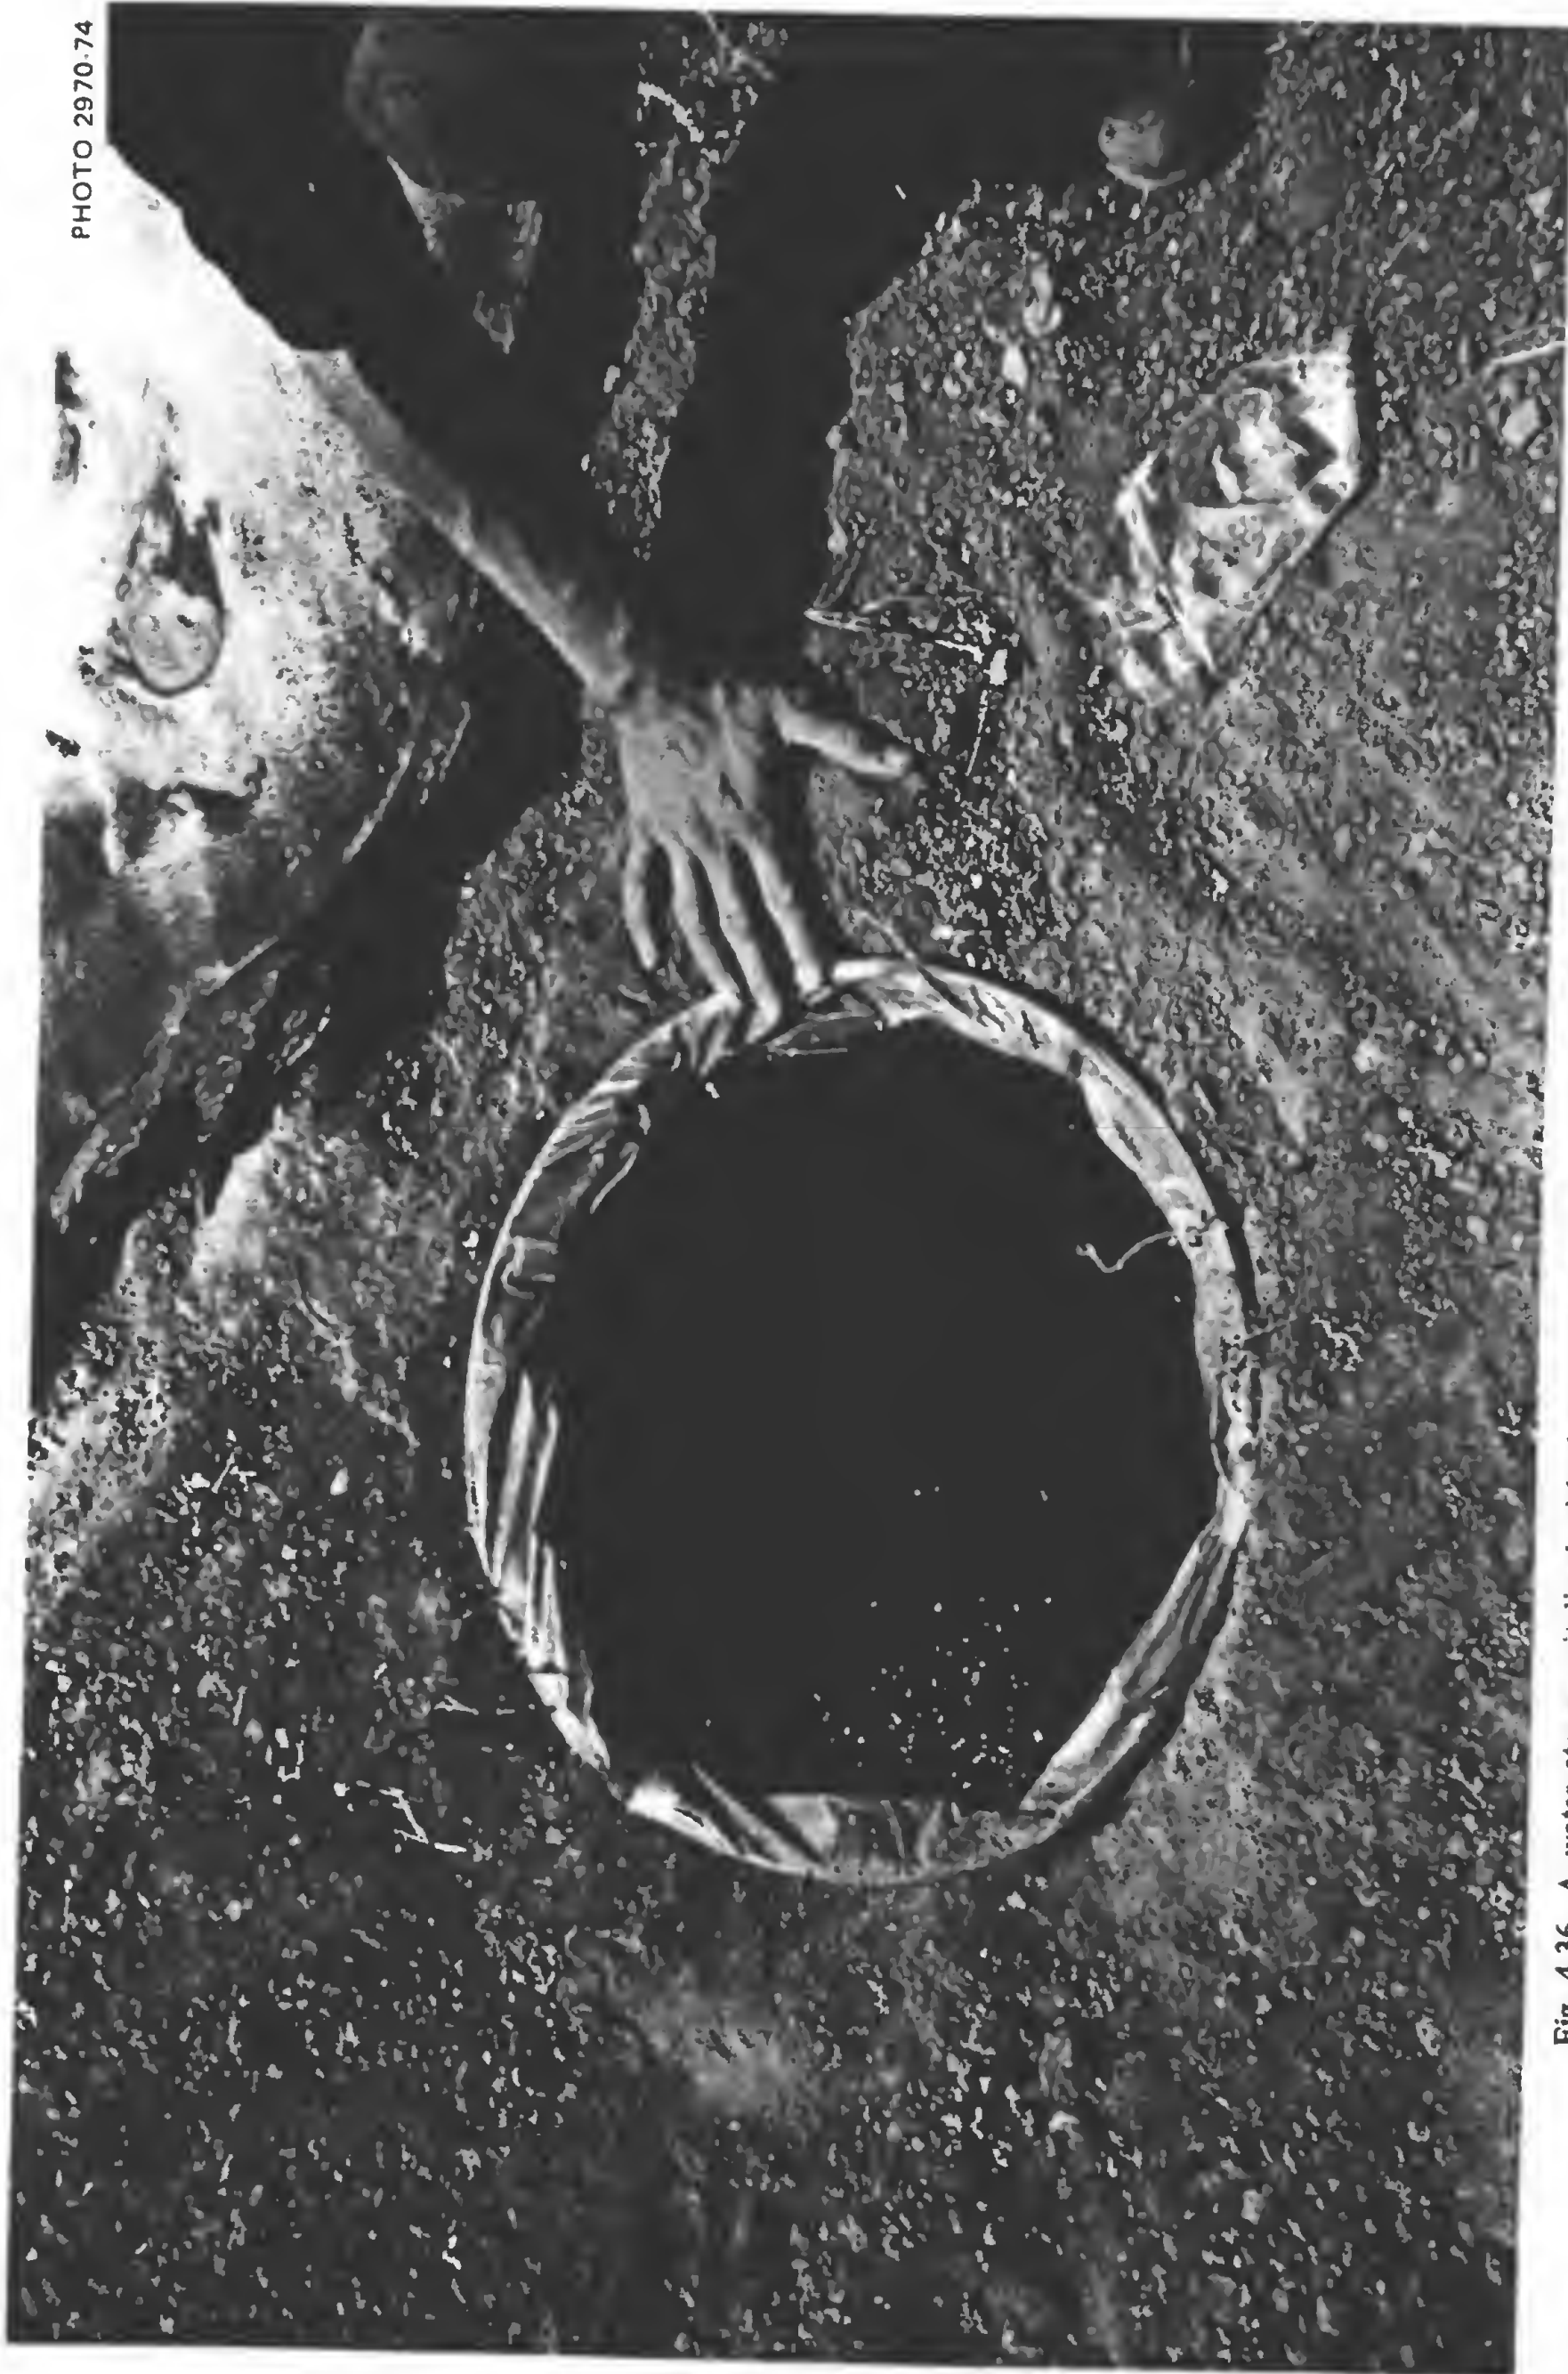
Fig. 4.36. A water storage pit lined with plastic bags, photographed 6 days after having been filled and covered. None of the approximately 25 gallons of water in this pit had leaked through the two 30-gallon trash bags (each about  $1\frac{1}{4}$  mils thick) placed one inside the other for a pit lining.

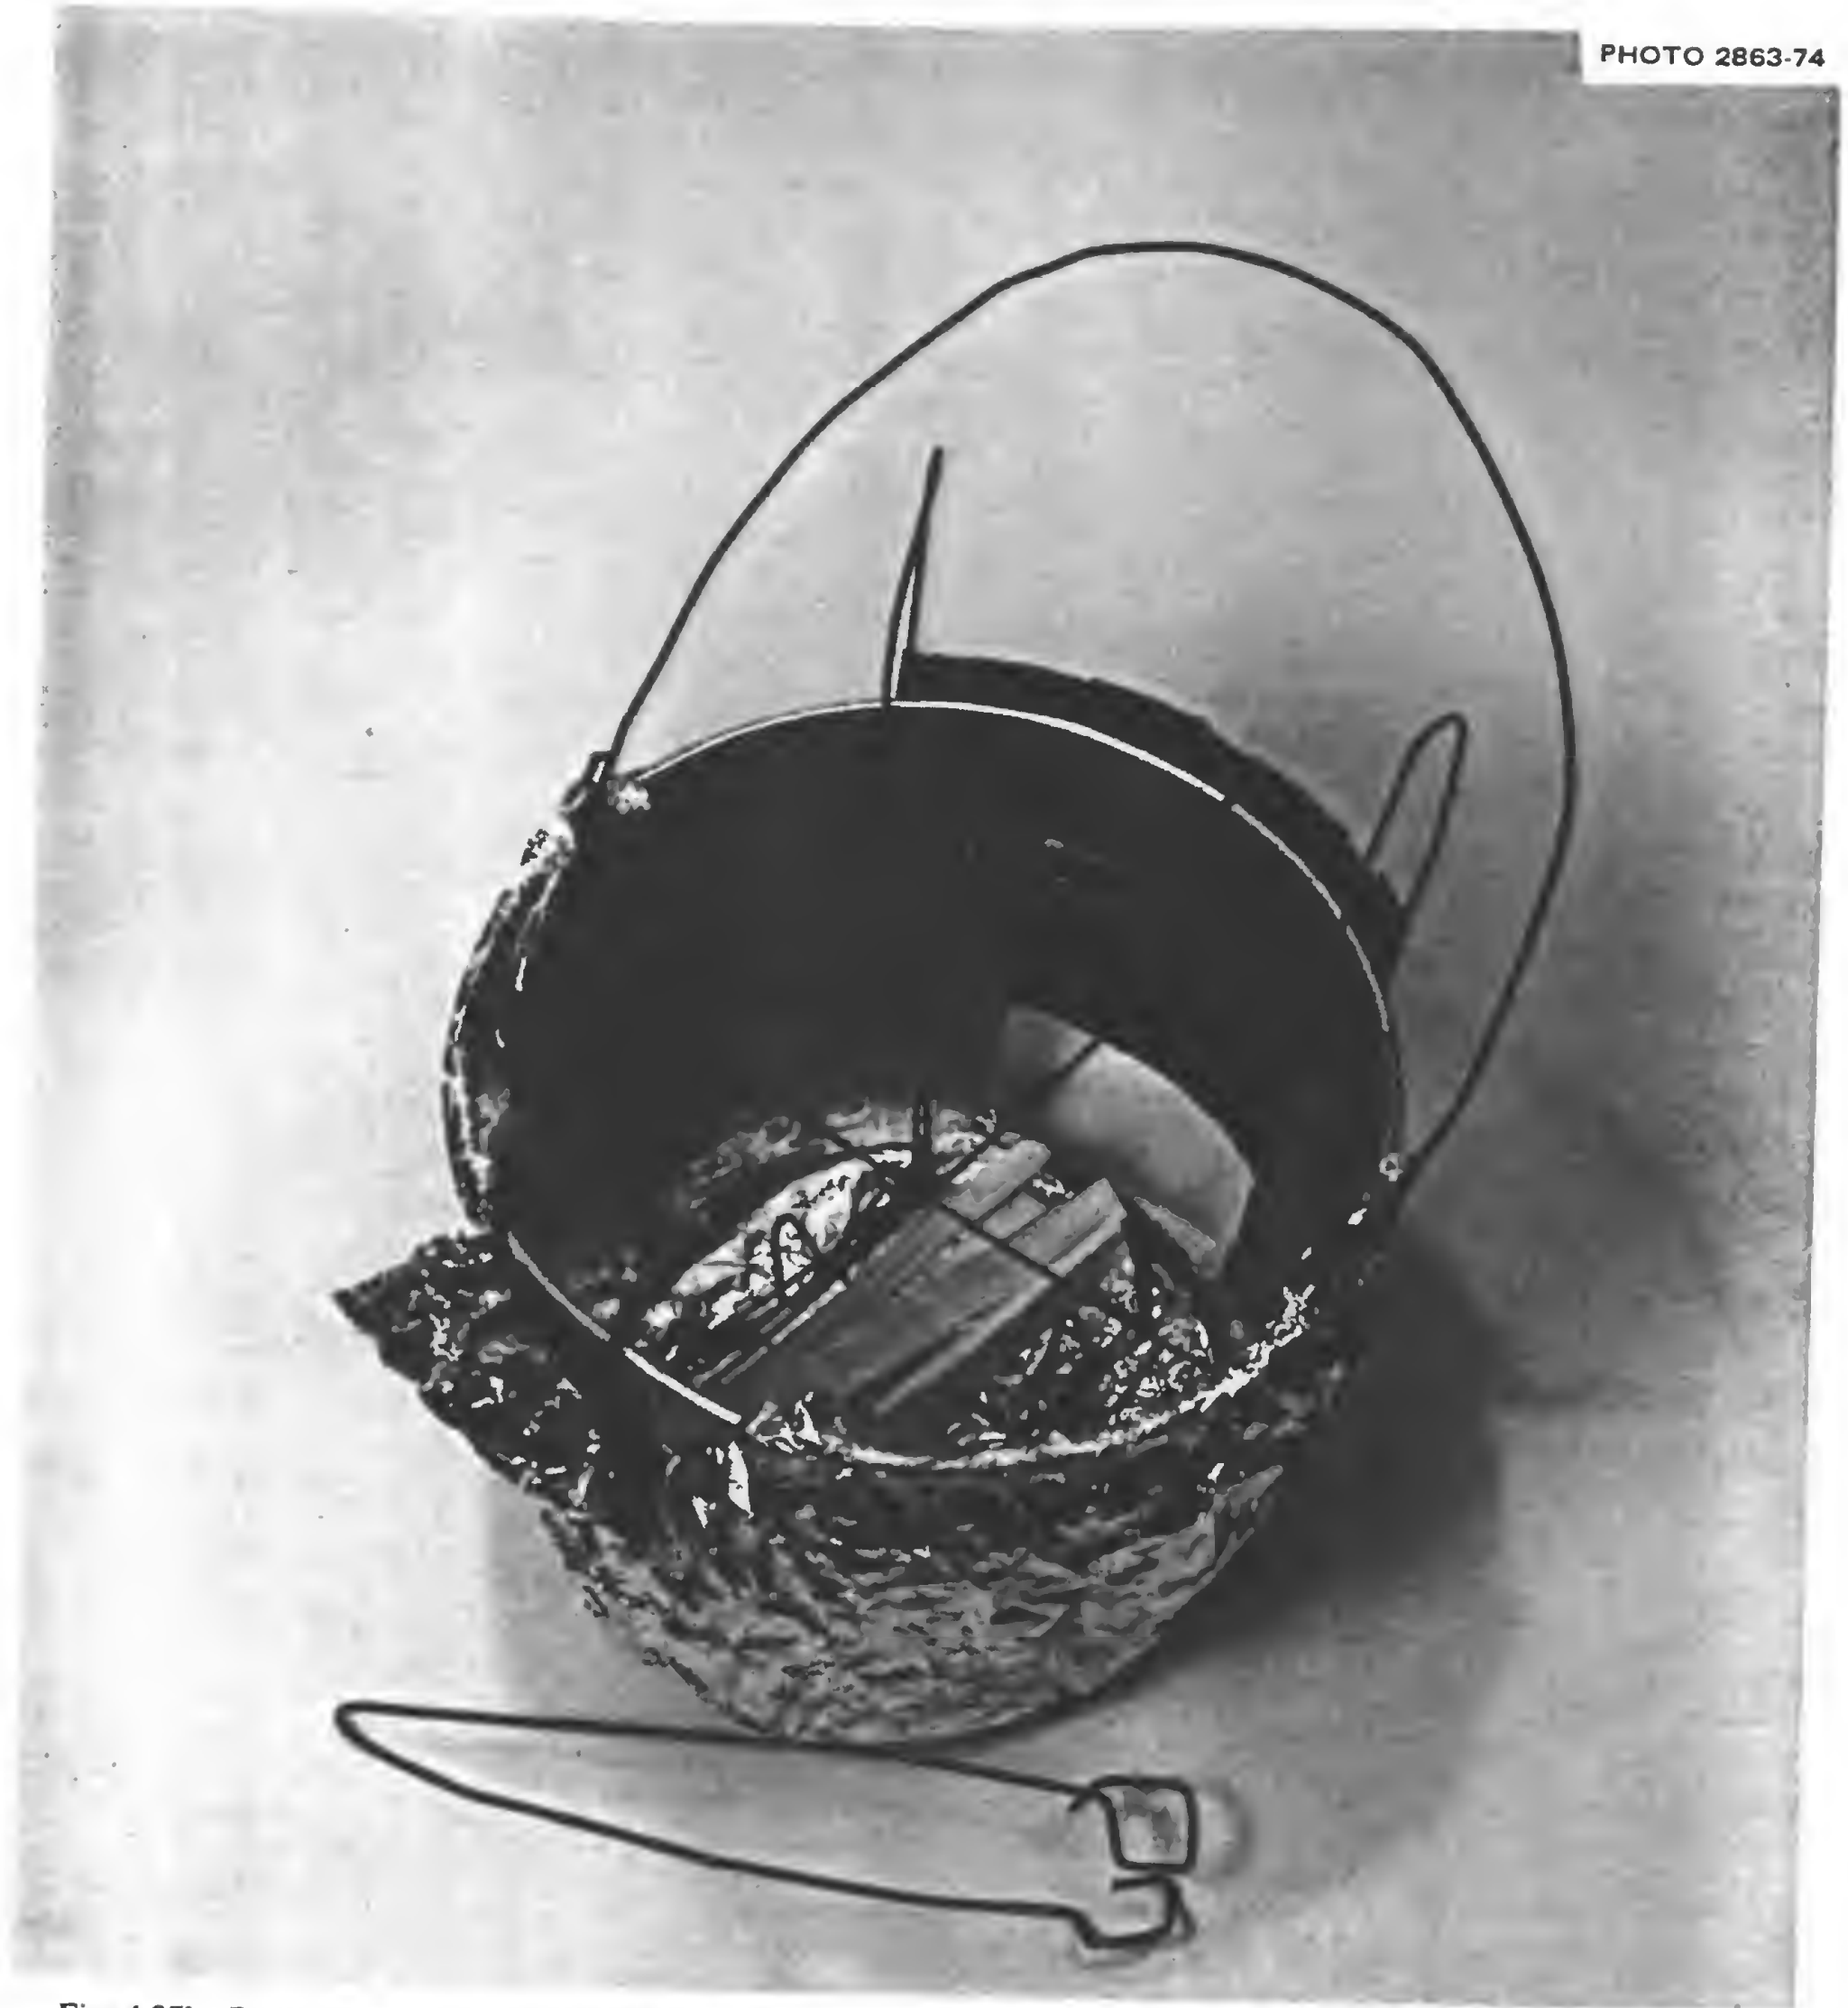
Fig. 4.37b. Bucket-Stove, showing its adjustable sliding damper partly closed, and the two coat-hanger wires that serve as pot supports. The ends of these wires are bent over the top of the bucket to form protruding springs to center and secure the pot by pressing against its sides. Pieces of wood about  $\frac{1}{2} \times \frac{3}{4} \times 6$  in. are best.

When this stove is used with a covered-lid pot having a diameter about 2 in. less than the diameter of the bucket (or large can) at the height of the bottom of the pot, 3 quarts of water can be raised from 60°F to boiling by burning only about 7 ounces of dry wood or paper.

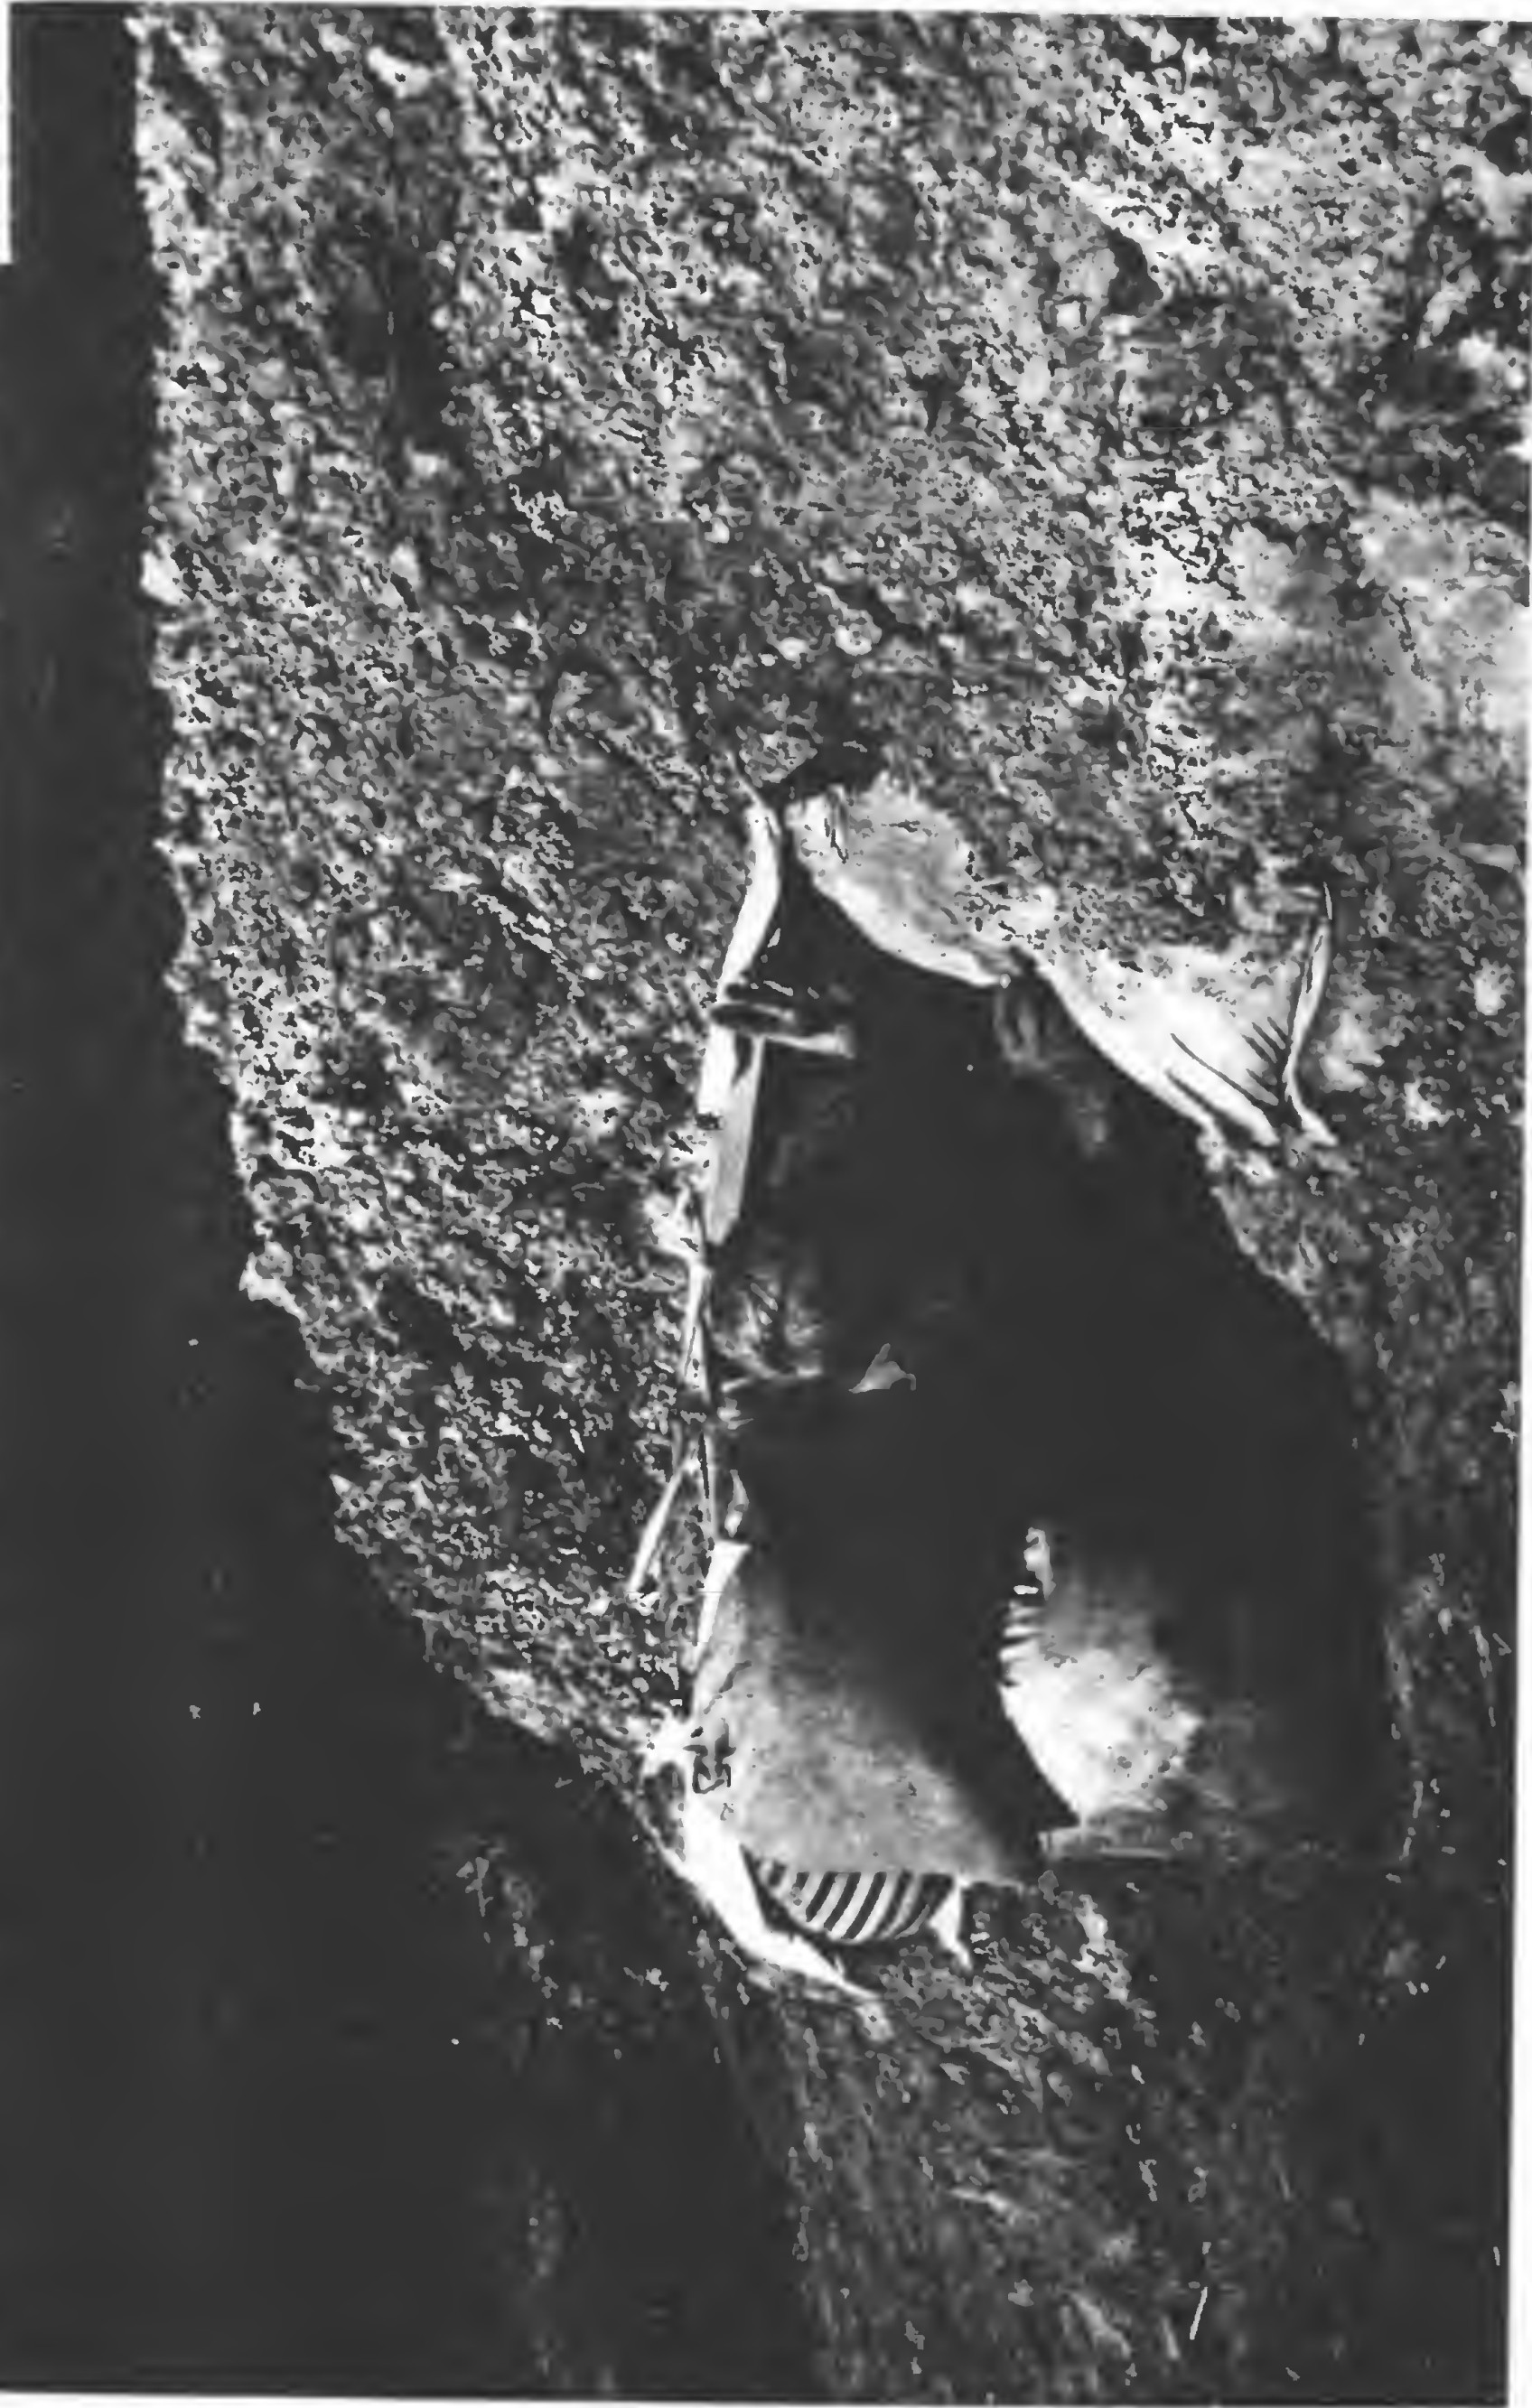
Fig. 5.10. A closeup view of the same entry pictured previously, showing the sandbags used to finish the ends of the entryway walls and to reduce radiation from fallout on the ground, which otherwise would enter the shelter. This shelter, like the other above-ground shelters designed for use in a hot, humid climate, had two entryways, facing in opposite directions, one at each end.

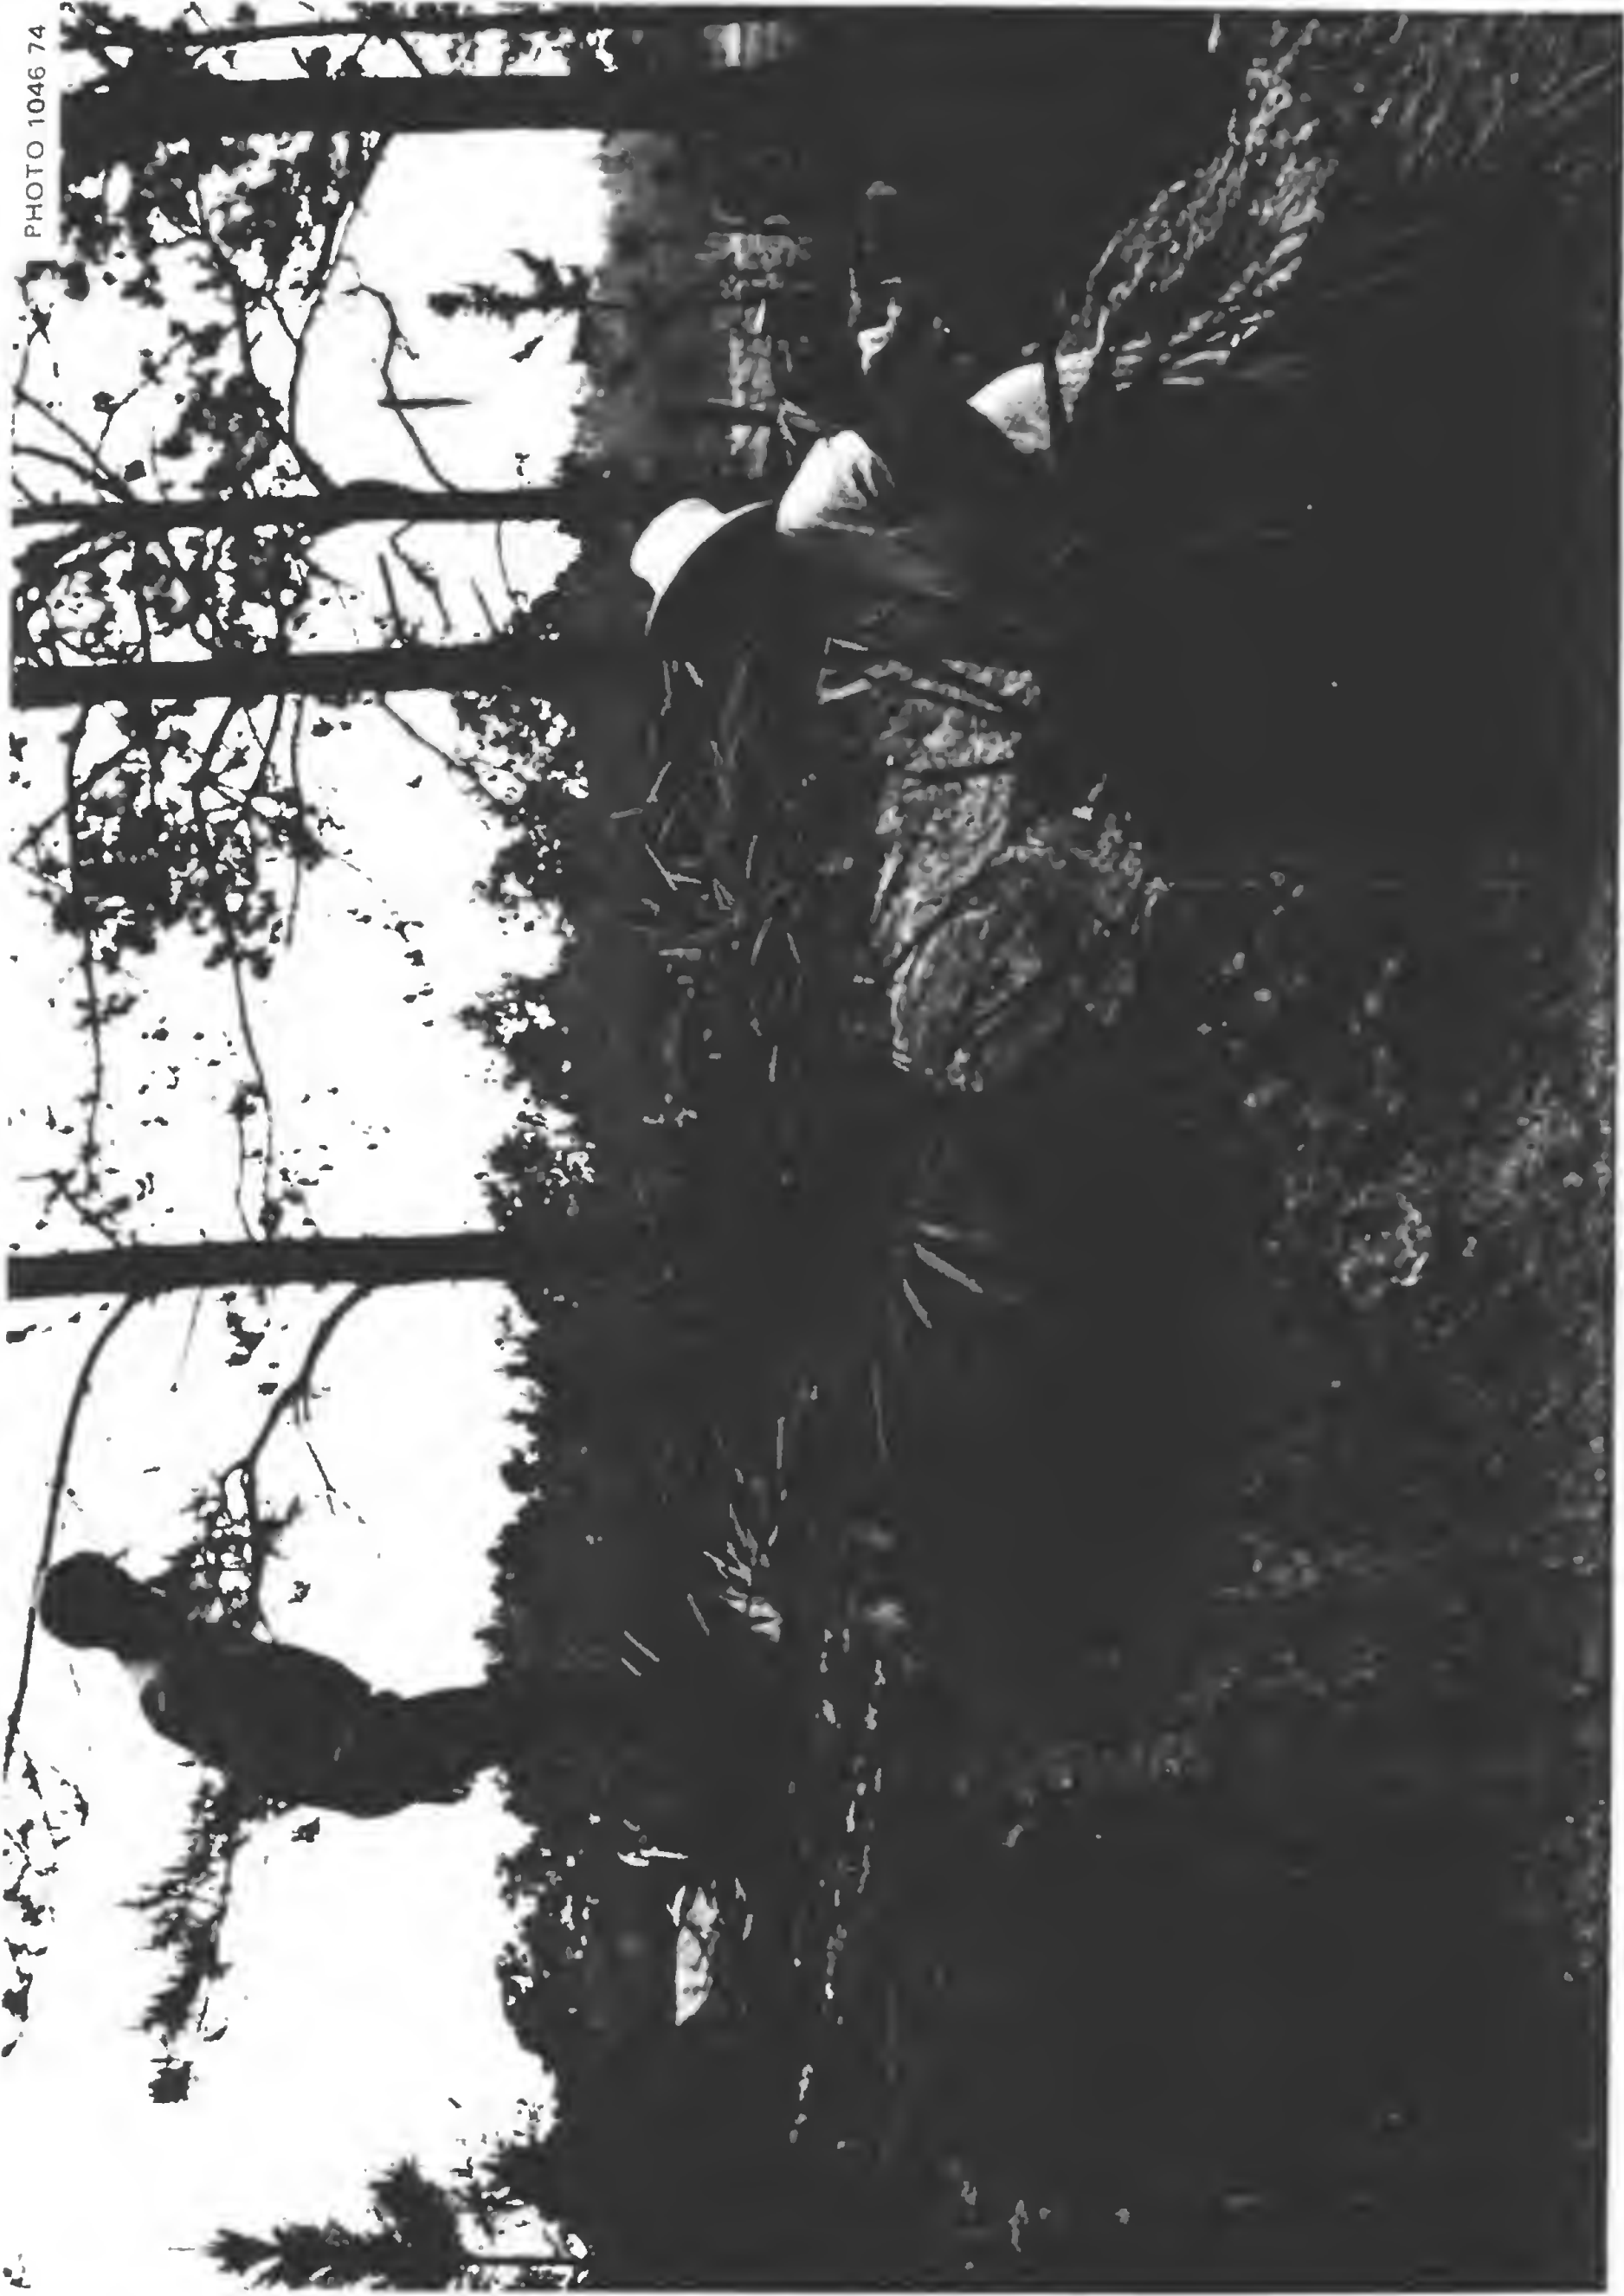
Fig. 5.21. Since this family lacked newspaper, cardboard, or other material to keep sand from sifting through the cracks between the roofing poles, they used palm leaves for this purpose. Grass or pine needles could have been used, but would have required more work, and might have contained ticks and chiggers.

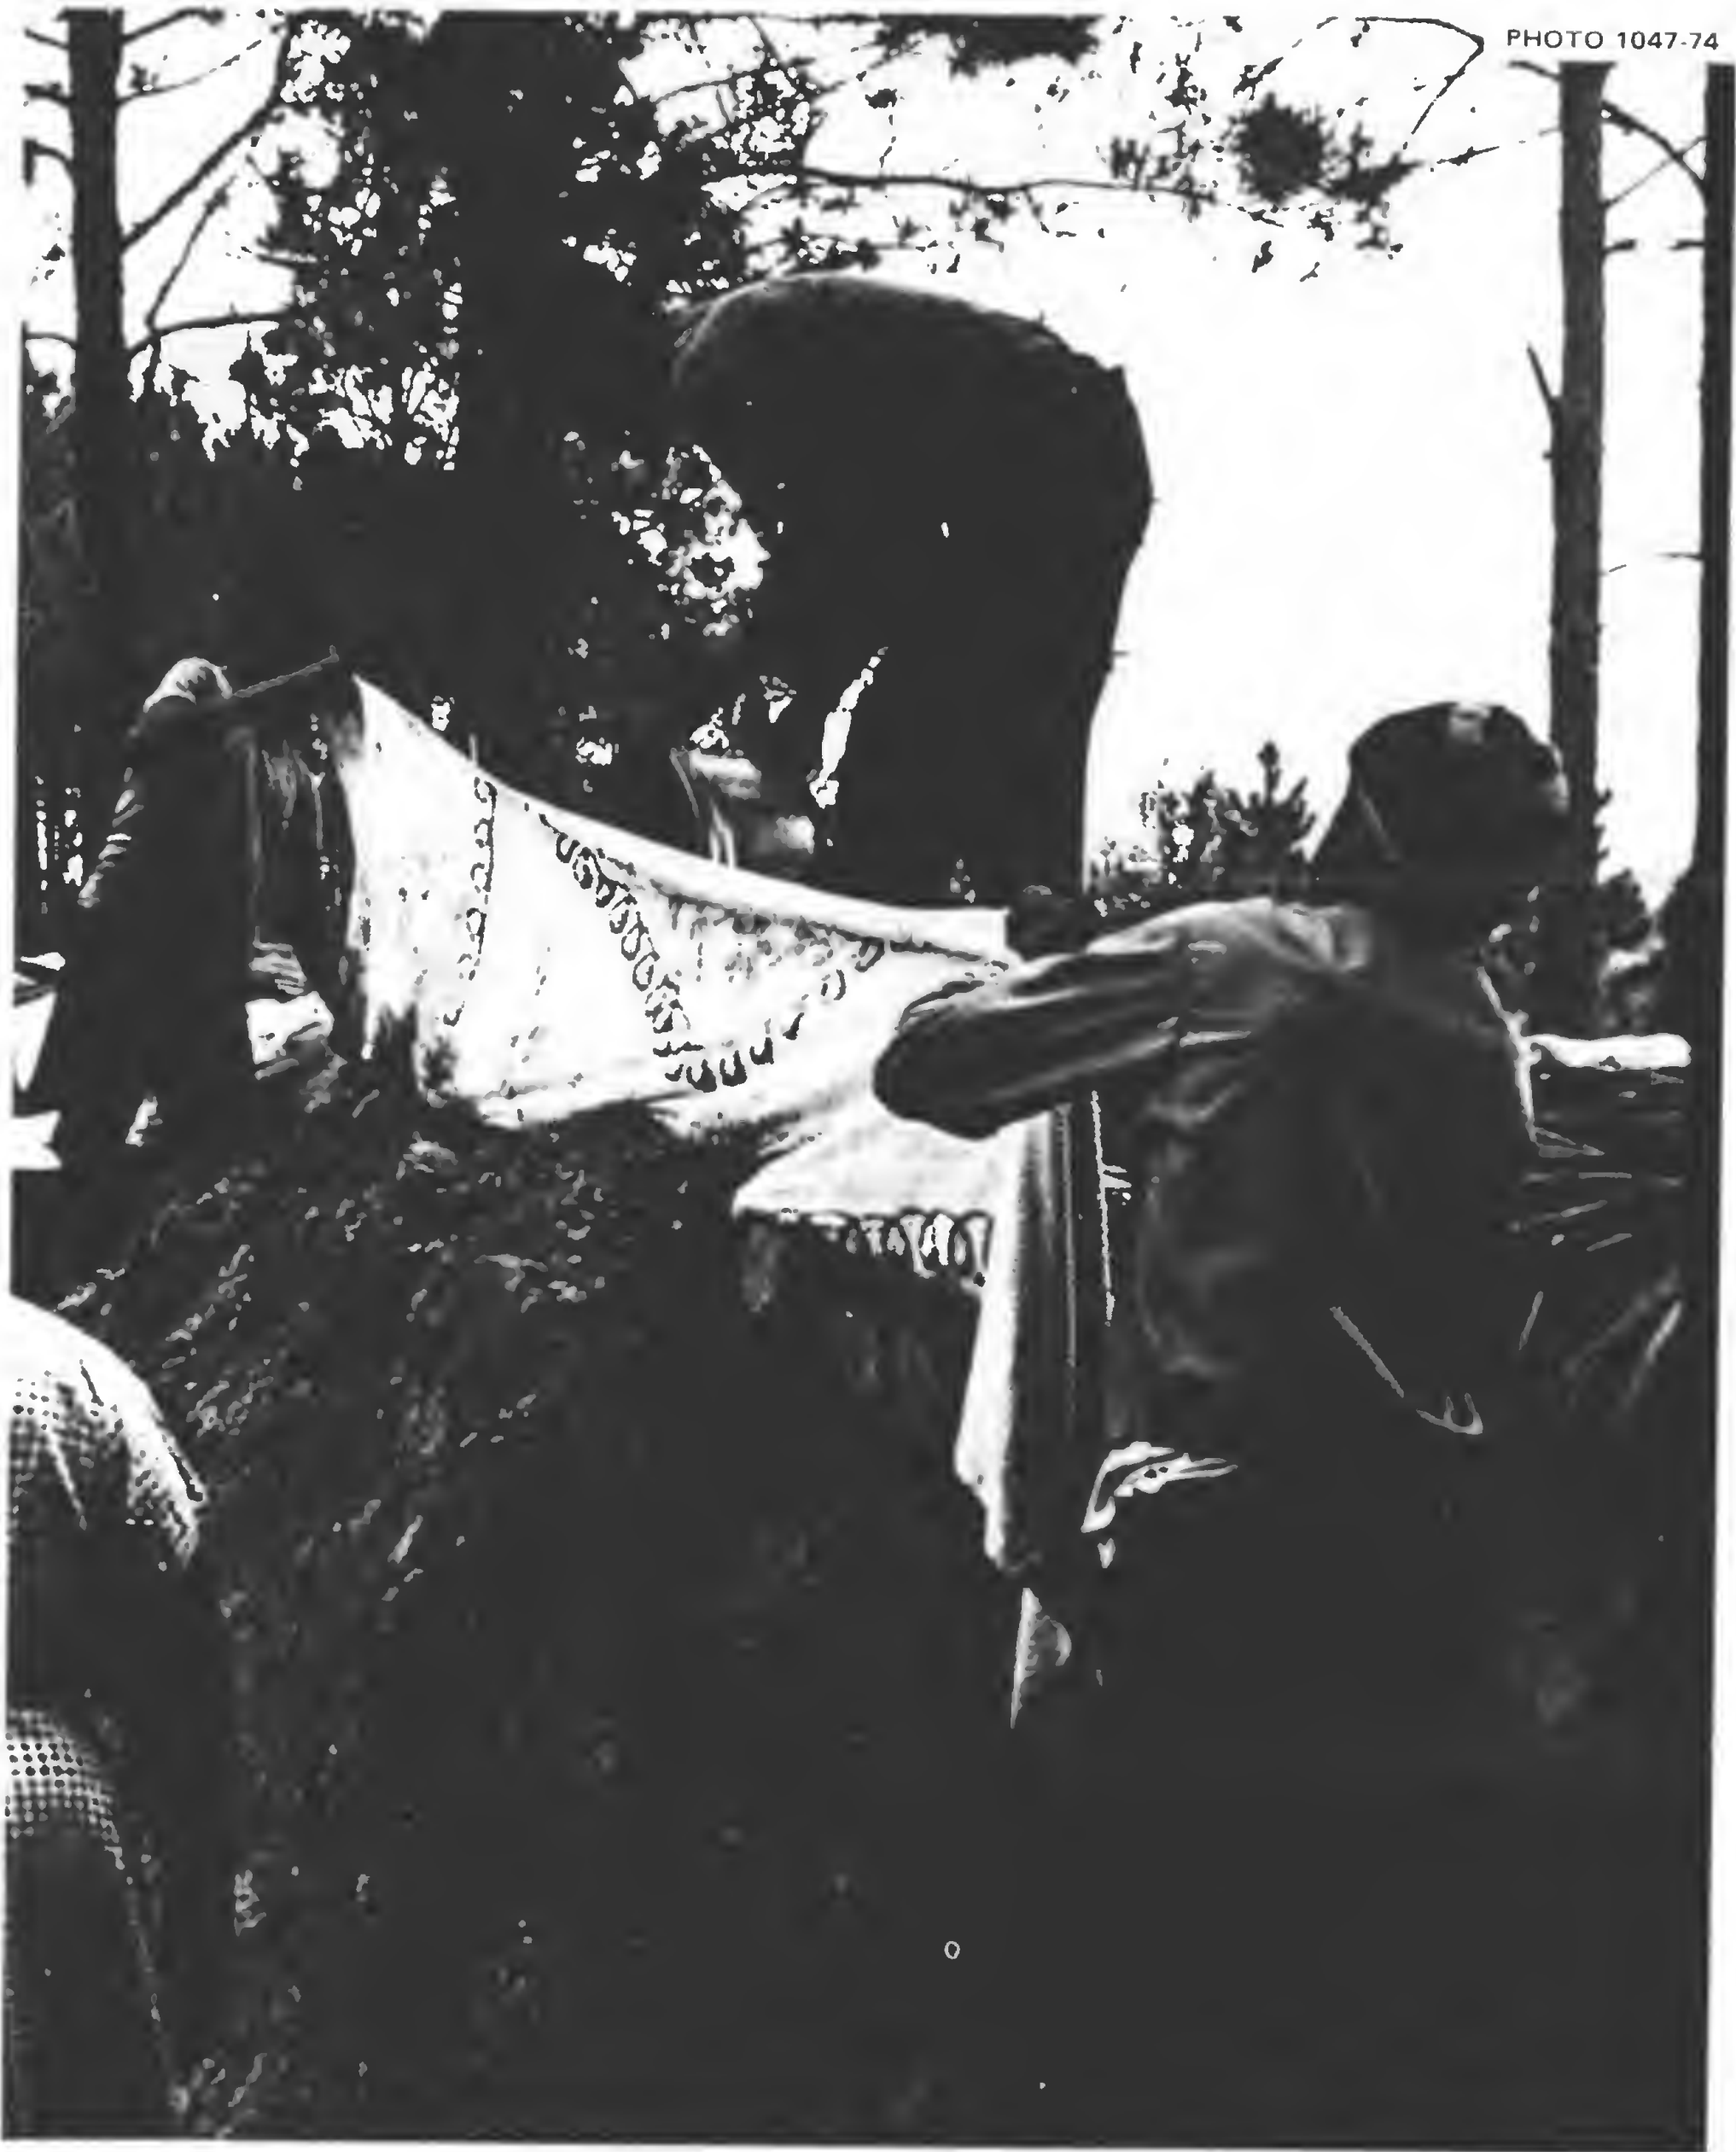
Fig. 5.22. Using an old bedspread to form an earth-filled roll along an upper edge of the essentially flat shelter roof of poles. The father is pouring earth out of a large bucket. These rolls made it possible to increase the stability of the earth covering around the edges of the roof, and also prevented heavy rains from washing any appreciable amount of shielding earth off the shelter roof.

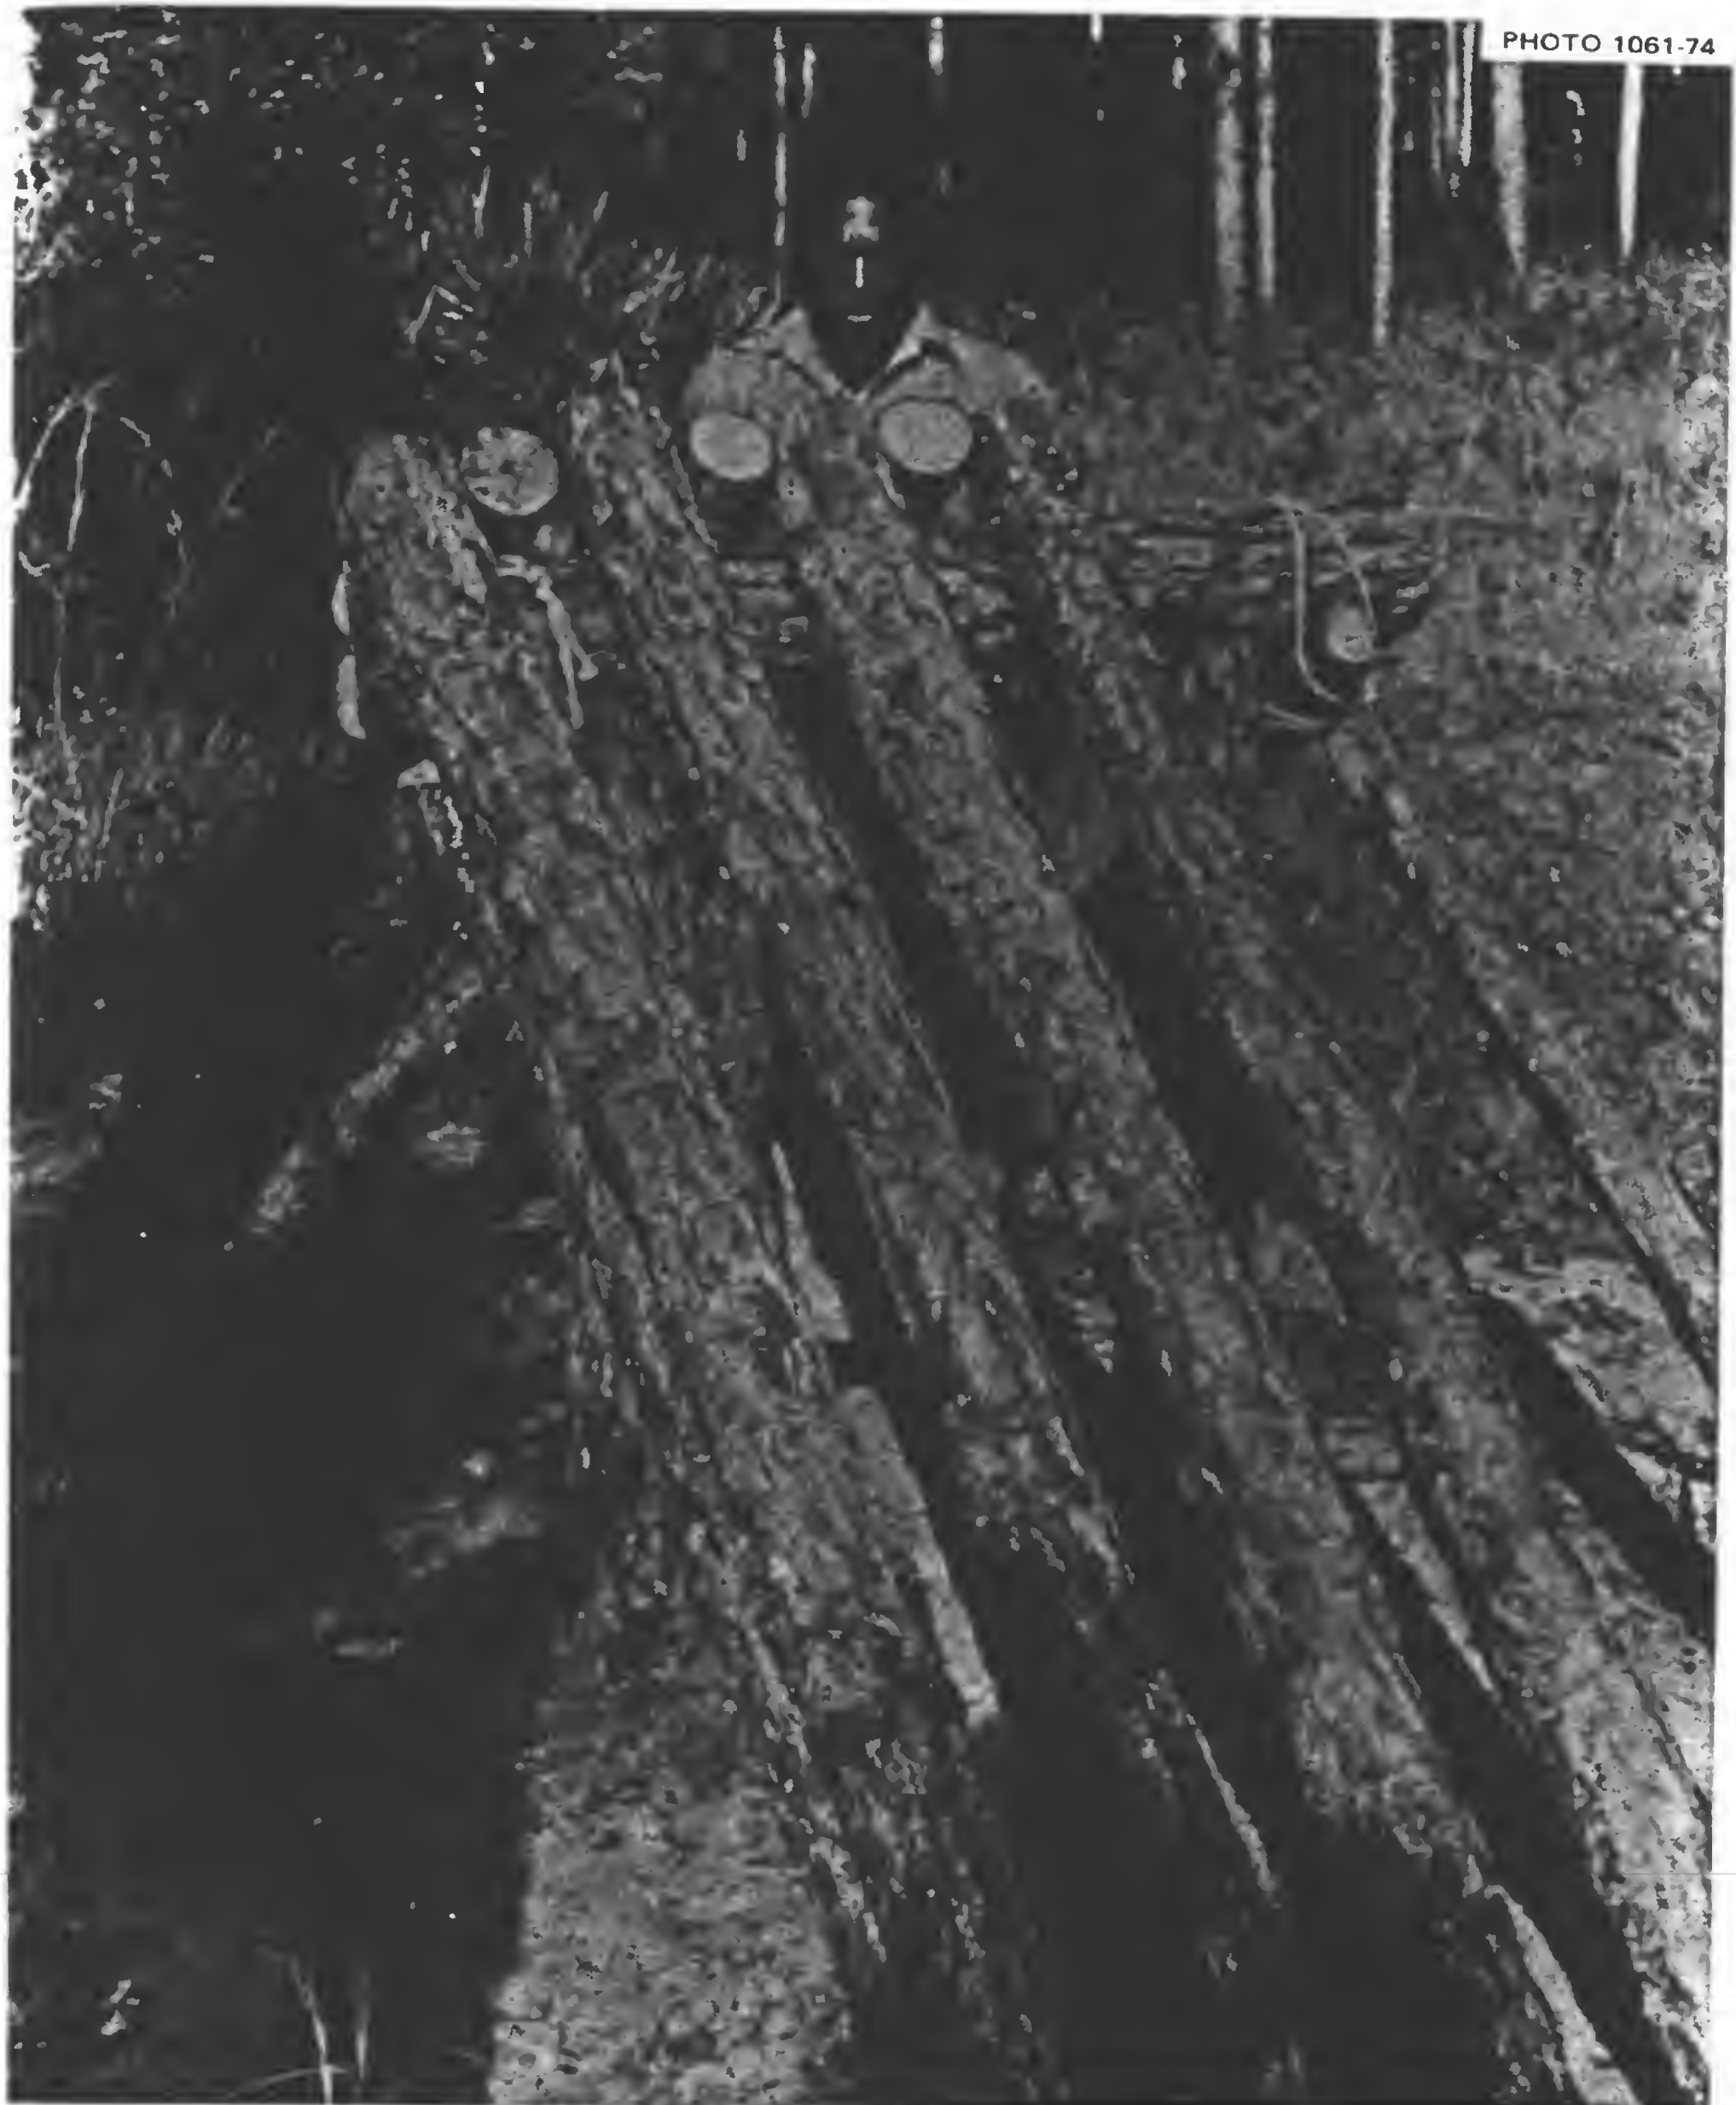
Fig. 5.30. The first prototype of a Ridge-Pole Shelter built by Kearny and a contractor's workmen. The ridge pole of this prototype was supported by 2 vertical posts, each of which had a shallow notch in its upper end, in which the ridge pole rested. This first prototype had cross-braces with their ends under the ridge pole to steady it; subsequent loading of this structure with over 2 ft of earth indicated that this cross bracing was unnecessary.
